## ACCIDENT INVESTIGATION REPORT

**Case:** Fall from Heights / Tina Werner

**Location:** Go Ape Lums Pond, LLC  
Lums Pond State Park  
1042 Howell School Road  
Bear, DE 19701

**Date/Time:** Wednesday, August 24, 2016 at 2:30pm

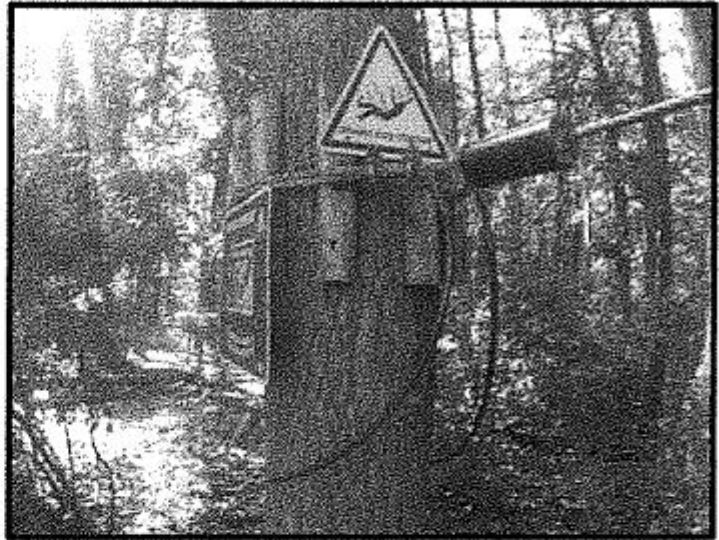
Yellow signs in the shape of a triangle that read “Always stay attached” are secured directly above all transfers from the crossing line to the red safety line. Proper connection points are denoted by the color red—the color of the jacket safety line that participants clip into while on a platform and the color of the red bumper on the horizontal life safety line which spans from tree-to-tree over each crossing.
