## Load Testing

### NSW SES Vertical Rescue Professional Development Workshop

#### *Wellington NSW*

Report by Alan Sheehan B.E.,  
Vertical Rescue Trainer,  
Oberon SES

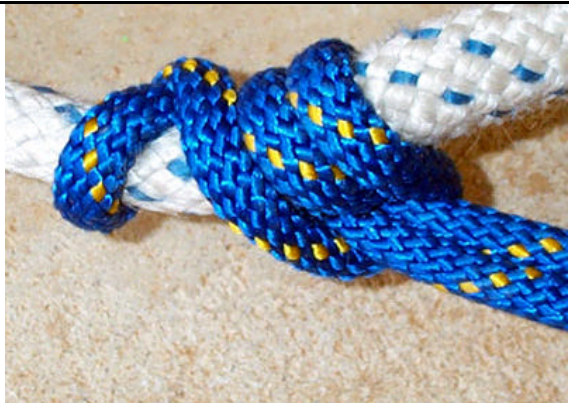
Comments	Load at "Failure"	Photo
6mm double wrap prusik loop on 13mm static life rescue line .	300 kgs

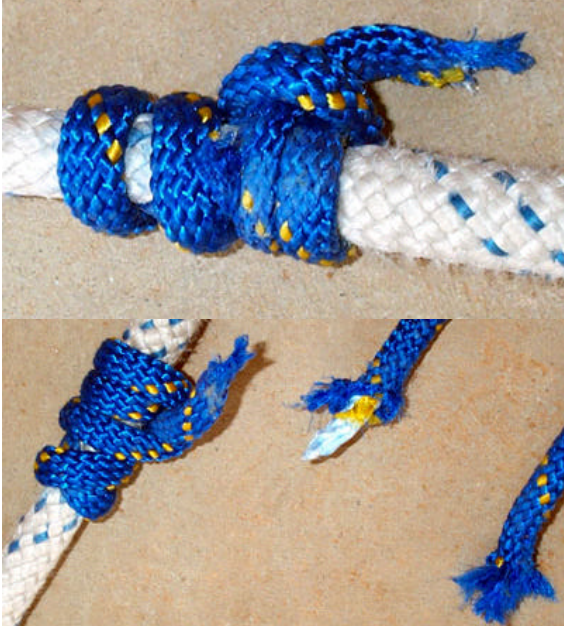
Comments	Load at "Failure"	Photo
<p><b>6mm triple wrap prusik loop on 13mm static life rescue line .</b></p> <p>Minor slipping at 650 kgs. At 1083 kgs both strands of the loop failed simultaneously at the prusik knot.</p>	<p>Began slipping at 650 kgs. Failed at 1083 kgs.</p>

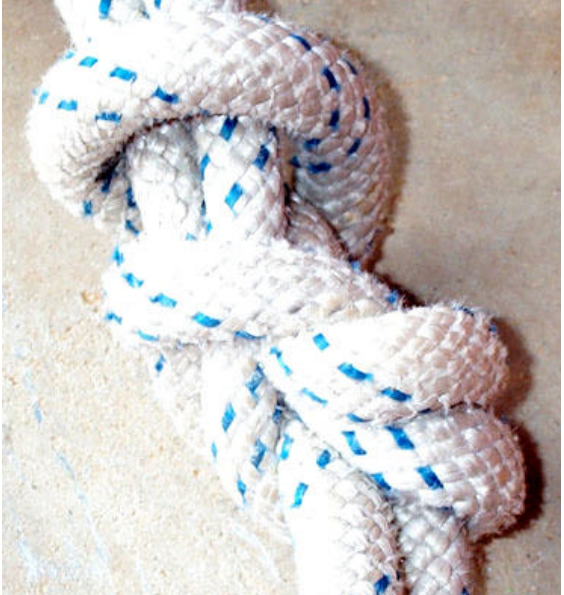
<p><b>Figure 8 loop.</b></p> <p>This loop was used to anchor the 13mm rope for the previous prusik tests. While this knot has not failed, this is how it looked after being loaded to 1083 kgs.</p>	<p>1083 kgs.</p>

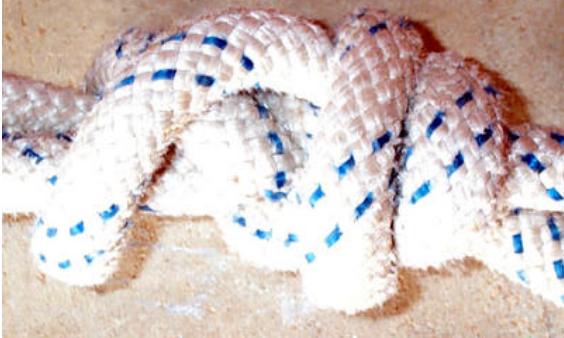
<p><b>Figure 8 v Figure 9 Loop.</b></p> <p>The previous figure eight loop (loaded to 1083 kgs) was tested against a newly tied figure 9 loop in the other end of the 13mm rope.</p> <p>The figure eight failed at 2074 kgs on the outside bend of the knot.</p>	<p>2074 kgs</p>

<p>The figure 9 after loading to 2074 kgs.</p>

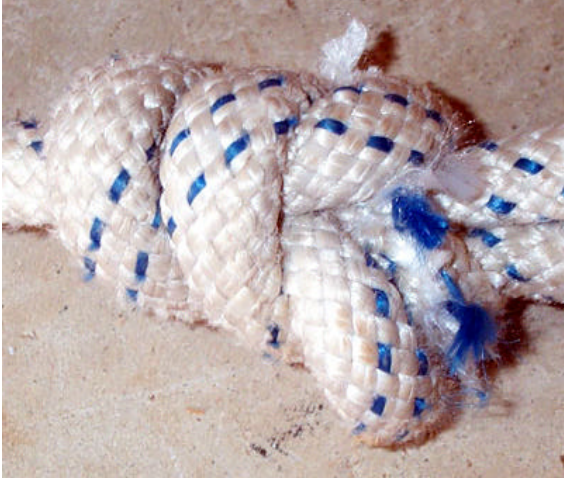
<p data-bbox="786 797 1351 831">The figure 8 at failure.</p>
<p data-bbox="240 835 571 909"><b>Figure 8 v Figure 9 loops.</b></p> <p data-bbox="240 947 571 1055">The figure eight was tested again against the figure 9.</p> <p data-bbox="240 1093 571 1496">At a load of approximately 2000kgs, the knots and rope started to audibly "crack". Again the figure 8 failed at 2190 kgs, with the rope between the knots stretching from 2.27 metres at no load to 3.4 metres at failure (50% stretch!).</p>	2190 kgs

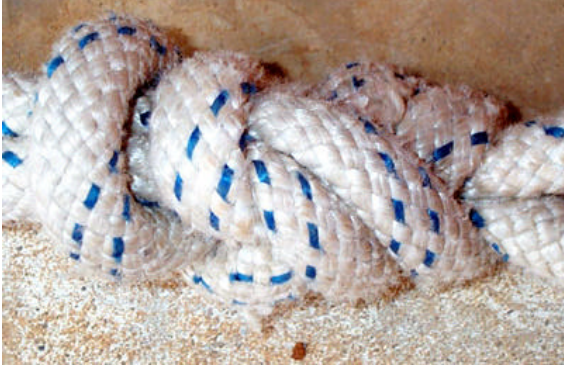
<p data-bbox="786 1200 1351 1234">The figure 9 after loading.</p>

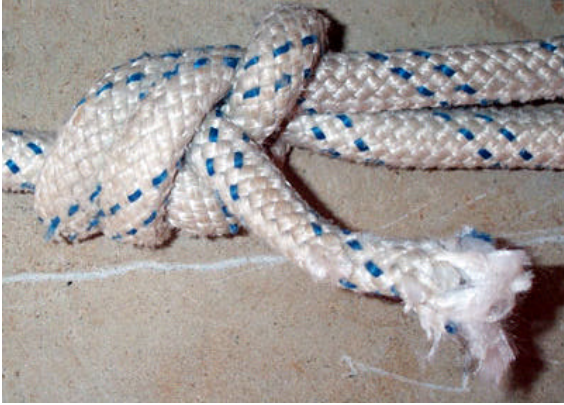
<p data-bbox="786 1637 1351 1671">The failed figure eight.</p>
<p data-bbox="240 1675 571 1783"><b>Tape sling, single strand, approx. 10 years old.</b></p> <p data-bbox="240 1821 571 2038">Tape was reportedly 1800 kg MBL Edelrid 25mm tube tape tied with a tape knot loop at each end. The tape failed at the tape knot. It was</p>	551 kgs.

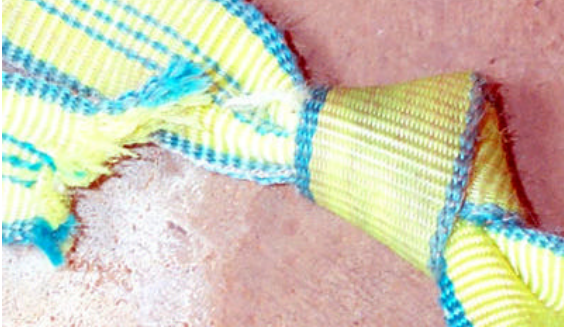
Comments	Load at "Failure"	Photo
noted that the outside bend of the tape knot failed.		
<p><b>Tape sling, single strand, &gt;10 Y.O.</b></p> <p>Tape was reportedly Bluewater mil-spec 25mm tube tape with an MBL of 2050 kgs. Once again the tape failed in the outside bend of the tape knot.</p>	758 kgs.

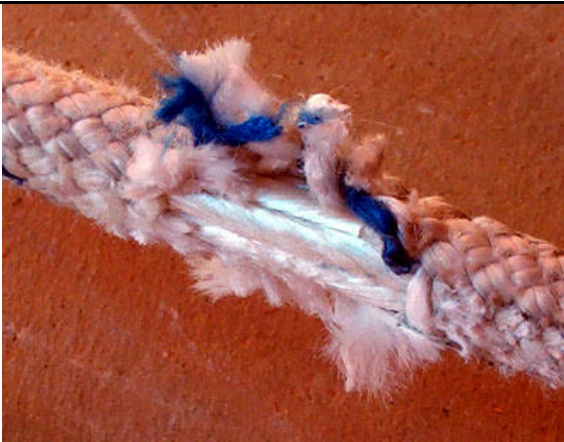
<p>A chunk of sheath torn out...</p>

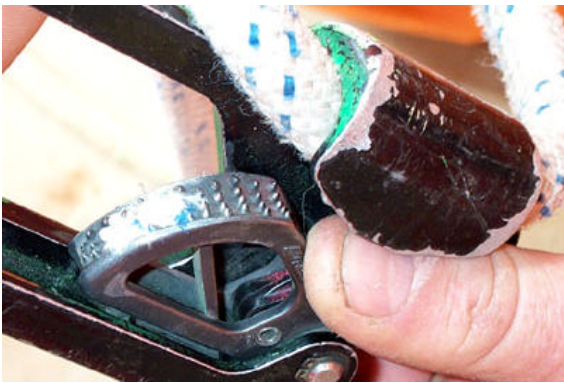
<p>The clogged teeth of the ascender cam.</p>

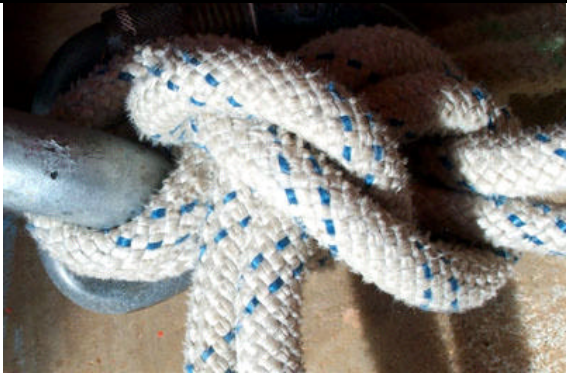
<p>The locked off Munter (Italian) Hitch after loading.</p>
<p><b>SRT A4 Ascender on 13mm rope.</b></p> <p>The previously loaded Munter hitch began slipping at 800 kgs.</p> <p>The SRT ascender completely severed the sheath at 848 kgs.</p> <p>The Munter hitch was still good.</p>	848 kgs

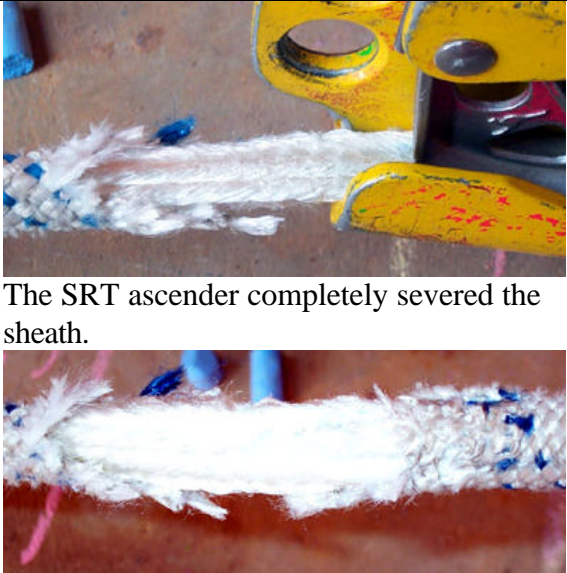
<p>The SRT ascender completely severed the sheath.</p>
<p><b>25mm tube tape both knots tied so inside bend of the knot is loaded.</b></p> <p>Compare 927 kgs with 758 kgs for outside bend in same tape.</p>	927 kgs

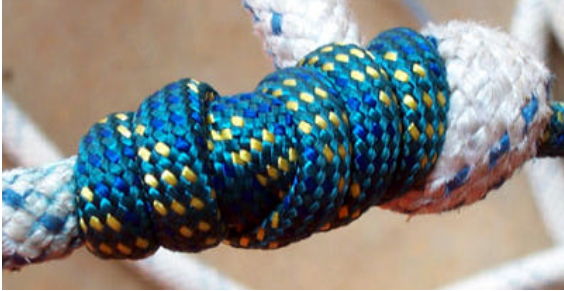
Comments	Load at “Failure”	Photo
<p>At 870 kgs the knot slipped and then retensioned at 708 kgs. It continued slipping, and the rope began to coil like a snake.</p> <p>Tape broke at 950 kgs at the Lark’s head formed at the exit to the Klemheist knot.</p>		
<p><b>4 Wrap Klemheist Knot in 8mm cord on a 13mm rope.</b></p> <p>Rope began twisting at 400 kgs. At 1160 kgs the knot slipped, and again at 1570 kgs. Finally at 1744 kgs the cord snapped inside the wraps (not at the exit loop).</p>	1744 kgs

<p>Note the twisting of the rope!</p>
<p><b>“Bloodknot” – single marlon spike / double marlon spike – tied in 8mm cord.</b></p> <p>Failed in the “single marlon spike” or overhand knot – the sheath severed and a length of core pulled through.</p>	893 kgs

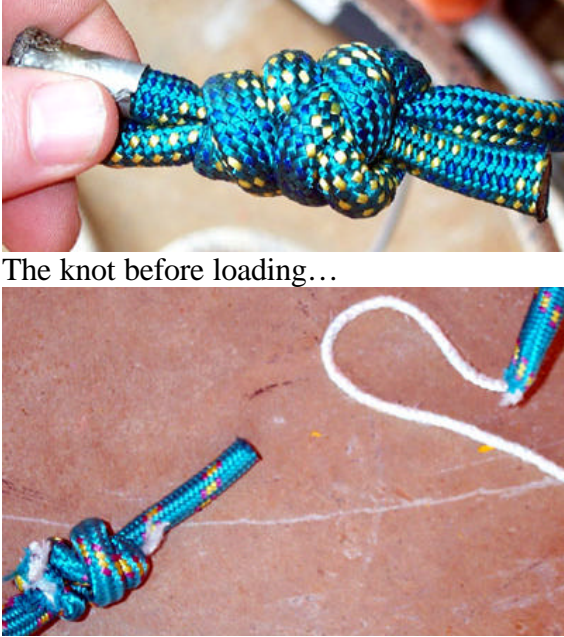
<p>The knot before loading...</p> <p>... and after.</p>

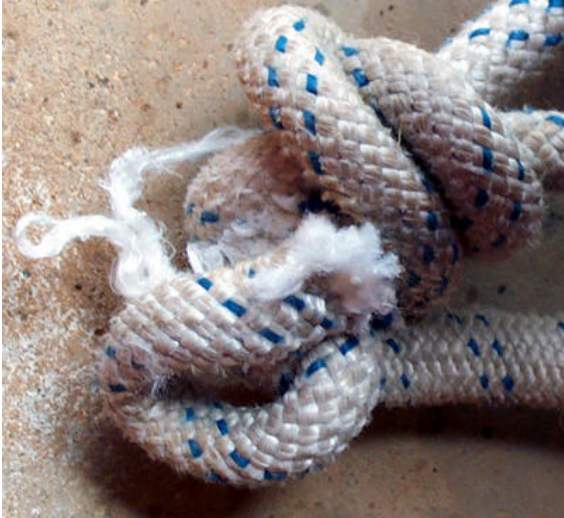
Comments	Load at “Failure”	Photo
<p><b>Bowline with a half hitch keeper vs a Double Fisherman’s Loop in 13mm static life rescue line.</b></p> <p>Failed at 1879 kgs at a lark’s head formed in the bowline.</p>	1879 kgs

<p>The failed bowline.</p>

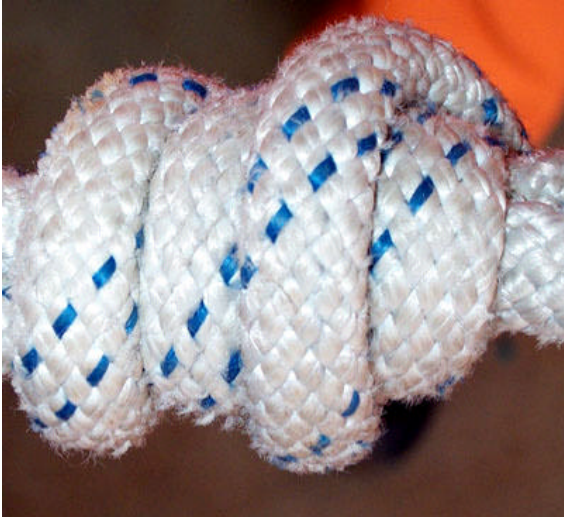
<p>The double fisherman’s after loading.</p>
<p><b>Triple wrap Prusik knot tied in 25mm tube tape on 13mm static life rescue line.</b></p> <p>This was a curiosity test to compare with a klemheist in tape. It is obvious why a prusik knot isn’t used in tape! Slipped at 30 kgs.</p>	30 kgs	No photo available

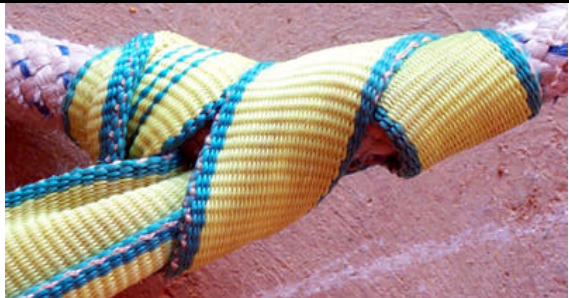
Comments	Load at “Failure”	Photo
<p><b>Double wrap Prusik knot tied in 25mm tube tape on 13mm static life rescue line.</b></p> <p>Slipped at 50 kgs.</p>	50 kgs

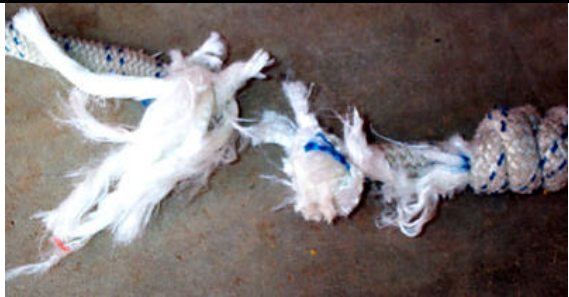
<p><b>Single wrap Prusik Knot (Lark’s Head) in 25mm tube tape on 13mm static life rescue line.</b></p> <p>Slipped at just 3 kgs!</p>	3kgs	No photo available.
<p><b>Figure eight loop vs Double Fisherman’s knot vs Figure 10 (Stevedore’s) knot in 13mm static life rescue line.</b></p> <p>Failed at the double fisherman’s at 2116 kgs. Close observation showed the sheath failed momentarily before the core.</p>	2116 kgs

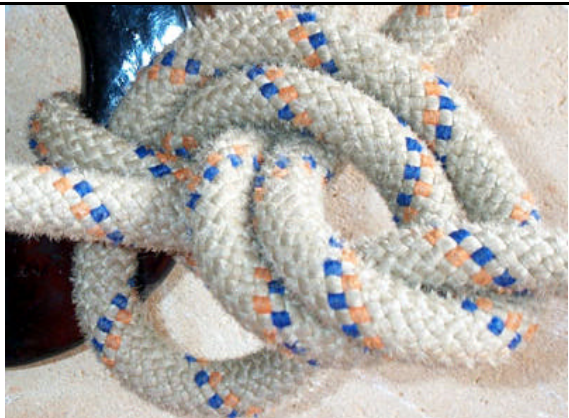
<p><b>Portuguese Bowline vs Buntline Hitch on the Bight.</b></p> <p>Portuguese Bowline failed at 1100 kgs.</p>	1100 kgs

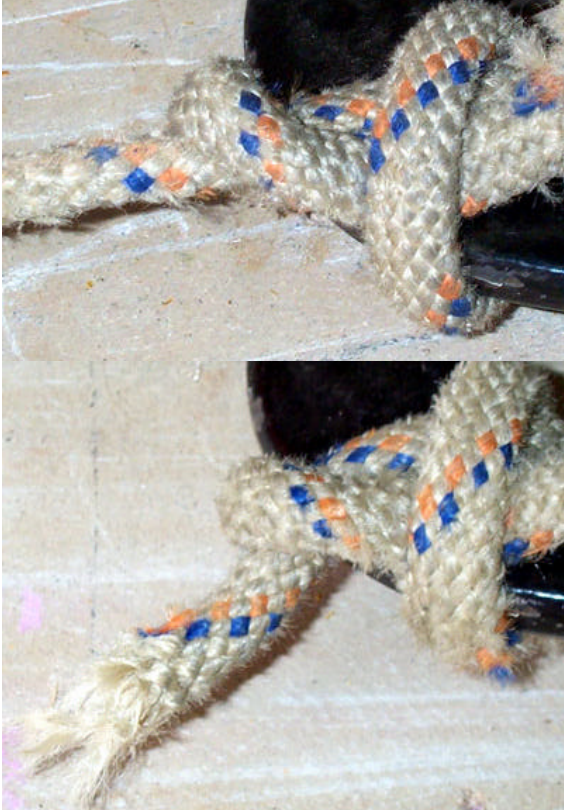
Comments	Load at “Failure”	Photo
<p><b>Clove Hitch vs Bowline in 11mm static life rescue line.</b></p> <p>Clove hitch rolled at 898 kgs, and failed at 1081 kgs just outside the knot.</p> <p>There was some conjecture that the cove hitch was not dressed in a natural form so this test was repeated as part of the following test.</p>	898 kgs

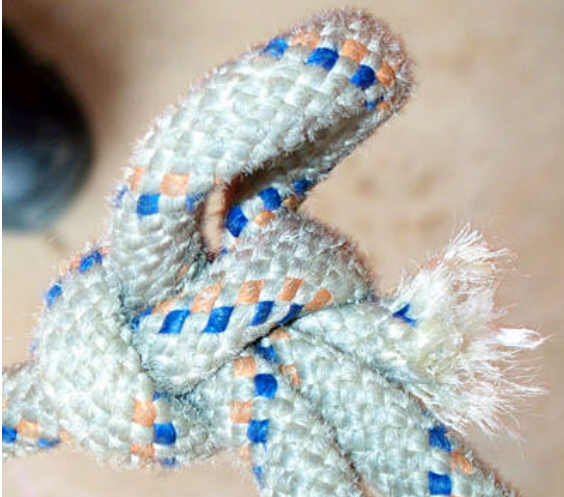
<p><b>Bowline vs Alpine Butterfly vs Clove Hitch in 11mm static life rescue line.</b></p> <p>The clove hitch was dressed in it's natural form compared to the previous test. It visibly performed better.</p>	<p>Clove hitch rolled at 1047 kgs.</p> <p>Alpine Butterfly Failed at 1121 kgs.</p>

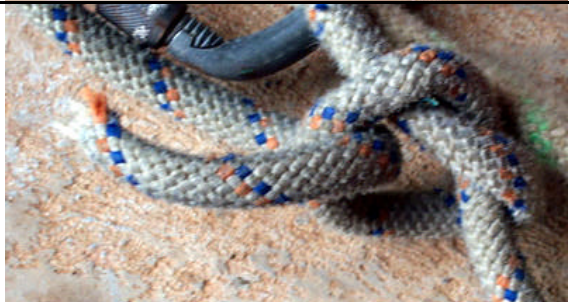
<b>Alpine Butterfly vs Alpine Clutch.</b>  Alpine Butterfly failed at 1065 kgs.	1065 kgs
