Load Testing

Alan Sheehan B.E.

The following load tests were completed in the Oberon State Emergency Service (SES) headquarters on the evening of July 29, 2004. The load cell is a StraightPoint NIP/5T 5 tonne load cell with remote read out unit. Calibration data confirms this load cell is accurate to +/- 2kgs over full scale. Force was applied using a 2.5 tonne Tirfor hand winch with a 2:1 MA pulley.

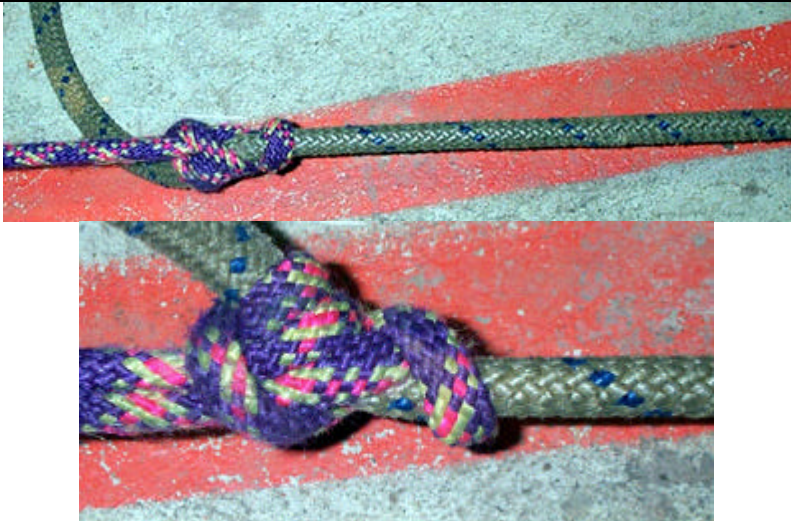
Test	Failure Load, kgs	Photo	Notes
7mm double wrap prusik loop	371

Prusik loop slipped at 371 kgs. Loop was well used and condemned due to localised damage to the sheath.

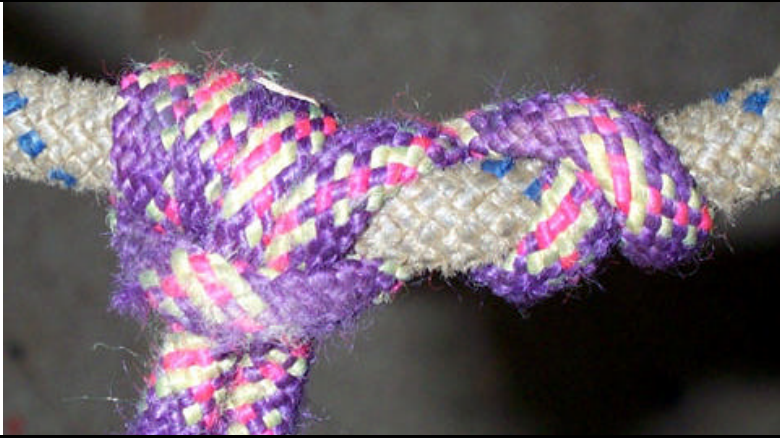
Test	Failure Load, kgs	Photo	Notes
7mm triple wrap prusik loop	>710

Prusik loop itself failed at 710 kgs at the location of previous sheath damage. (Same loop as used in the 7mm double wrap prusik test).
6mm double wrap prusik loop	409

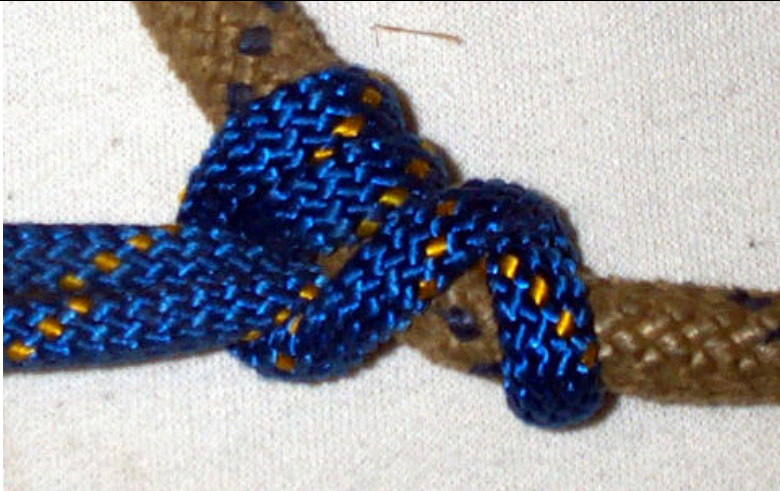
Prusik loop slipped at 409 kgs. Compare this with the double wrap 7mm loop and the “biting” effect of smaller diameter prusik loops is evident. The prusik loop appeared new though the history of the loop was not known.

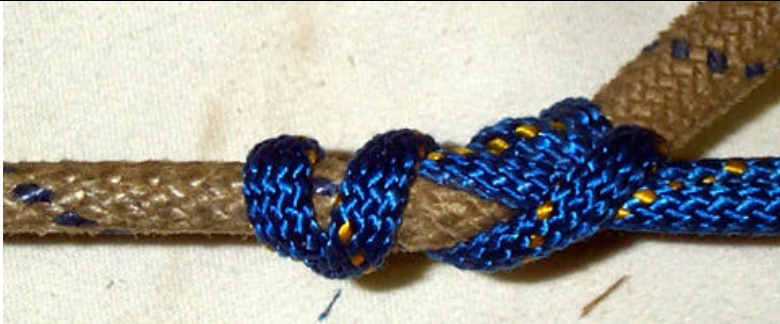
Test	Failure Load, kgs	Photo	Notes
6mm triple wrap prusik loop	921

Prusik loop slipped at 921 kgs. Same prusik loop as above.
6mm 4 wrap Klemheist knot	935

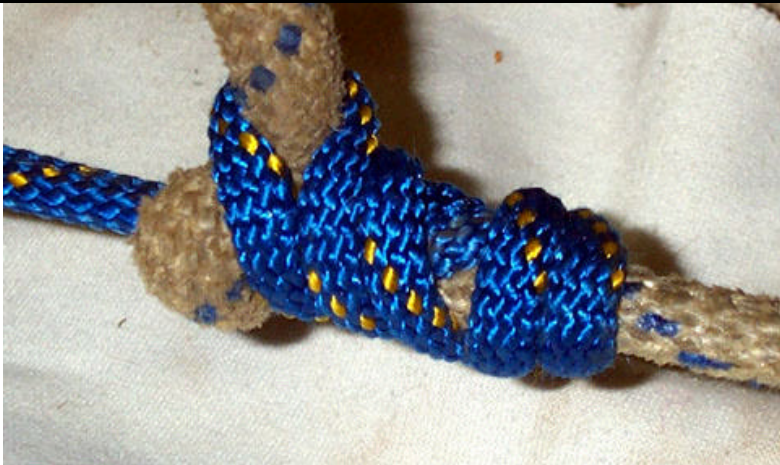
Loop failed in the knot at 935 kgs after slipping approximately 210mm and twisting the 11mm load line until the knot could not slip anymore. If you ever want to make a rope simulate a boa constrictor... this is how you do it!

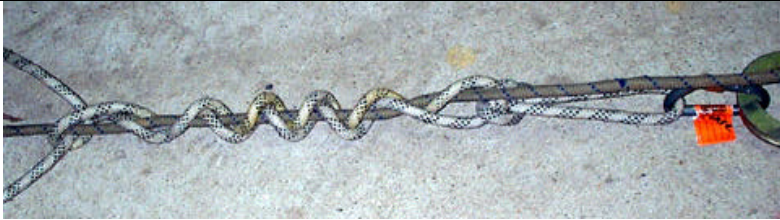
Test	Failure Load, kgs	Photo	Notes
11mm Rope Dog	>150

The 11mm rope dog was loaded to 150 kgs without slippage, however, the load had to be released and reapplied in order to straighten out a sling problem at one of the anchor points. On reapplication of the load the rope dog failed to reach the previous hold load of 150 kgs before slipping. The performance of the rope dog may have been affected by the rope combination: the load line was very stiff old Bluewater II while the rope dog was from very supple Edelrid 11mm static. Rope dogs are not part of NSW SES VR Protocol.
Abnormally loaded Figure Eight Bend	1371

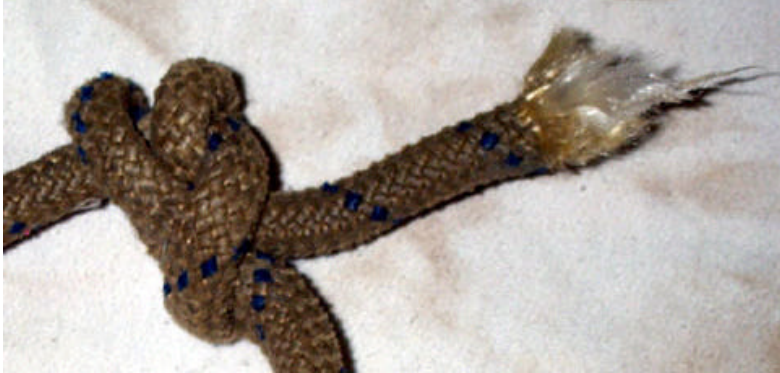
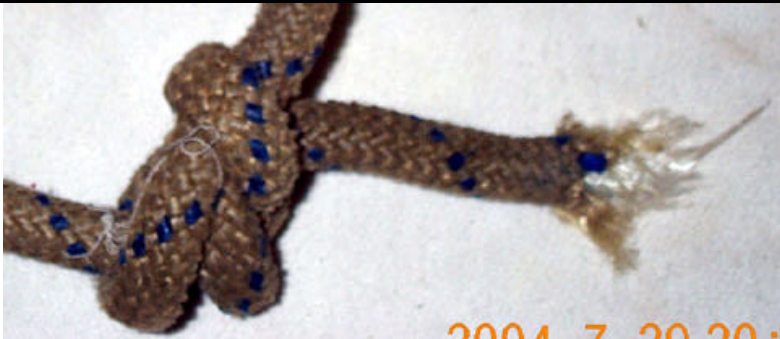
The 11mm load line failed in the knot exactly the same way it failed in a previous test at Kiama. The abnormally loaded figure eight bend is not part of NSW SES VR protocol. It has received much publicity in recreational canyoning circles as a suitable knot to join ropes because it presents a smooth face to pull down over the edge and so reduces the risk of jamming the knot on the edge, however, the author has observed first hand this knot slipping through while canyioners have been abseiling on it, and so expressly warns against the use of this knot. Both load tests the author has observed on this knot have shown significant slippage up until a high enough load was developed to “lock” the knot. The author speculates that

during abseiling activities there is insufficient load to “lock” the knot and so the knot continues to slip and should not be considered safe for life support.
Klemheist tape knot	>1371

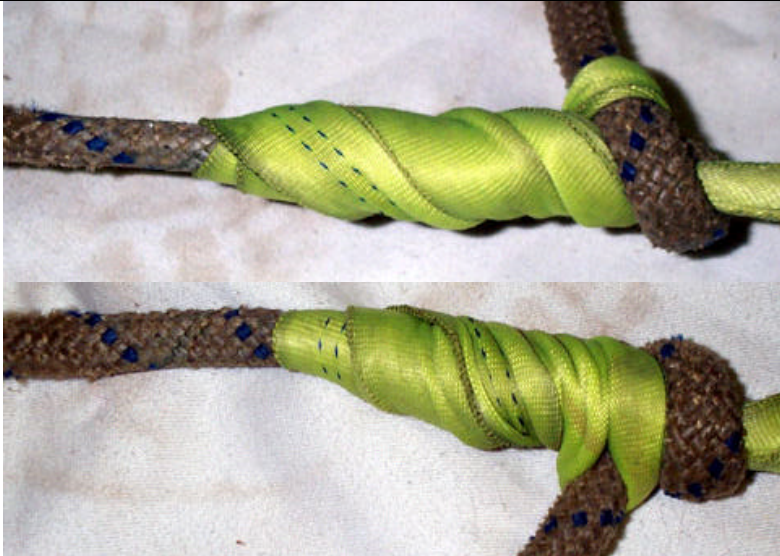
This knot was tested simultaneously with the abnormally loaded figure eight bend. Up until the figure eight failed, the Klemheist was behaving exactly the same was as the 6mm rope Klemheist in that it steadily twisted the 11mm load line as the knot slipped. The tape was 25mm mil-spec tube tape.

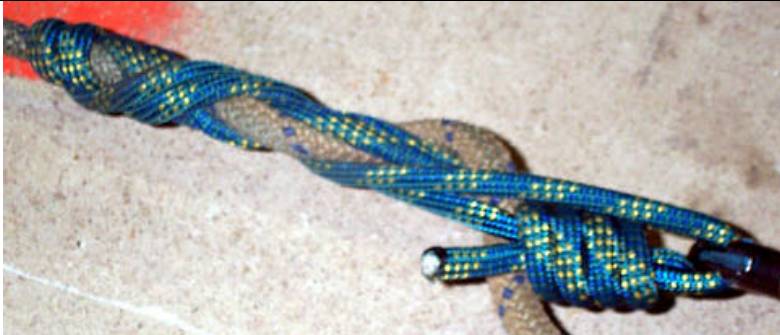
8mm French prusik	773

Slipped about 200mm at a maximum load of 773 kgs twice before welding to the rope. The prusik sling was fairly new 8mm static kernmantel cord. Note the weave patten of a French Prusik under load is similar to a rope dog, except that the overlapping part does not alternate as it does in a rope dog.

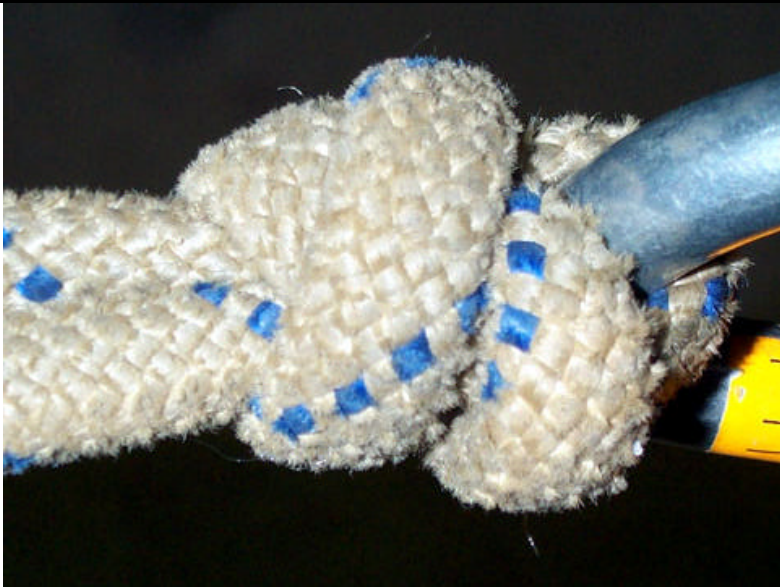
Test	Failure Load, kgs	Photo	Notes
Half Double Fishermans Loop	>1371

<p>This Half Double Fisherman's Loop was used to anchor the load line to the load cell for all the tests. This knot is not part of the NSW SES VR protocol. This knot was tested as it is a common anchor knot used by equipment suppliers in pre-rigged systems. It is compact and grips the attachment point (karabiner) very tightly. This test was not definitive. Further testing is required to compare it with both the Double Fisherman's Loop and the Figure Eight Loop which are preferred methods in the NSW SES VR Protocol. The author intuitively expects the Half Double fisherman's loop to fail at lower loads than the Double Fishermans loop.</p>
