## Load Testing

### NSW SES Vertical Rescue Professional Development Workshop

#### *Wellington NSW*

Report by Alan Sheehan B.E.,  
Vertical Rescue Trainer,  
Oberon SES

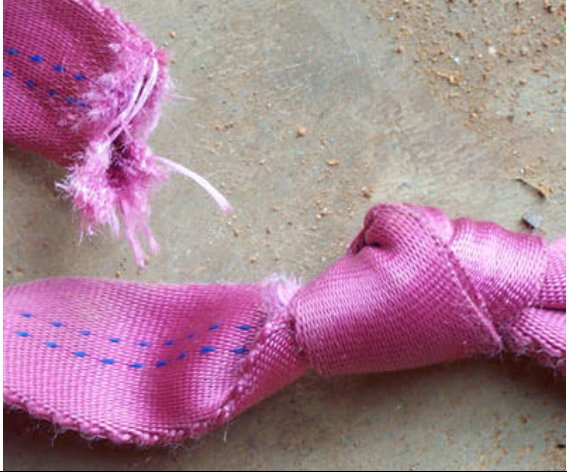
<p>The SRT ascender completely severed the sheath.</p>
<p><b>25mm tube tape both knots tied so inside bend of the knot is loaded.</b></p> <p>Compare 927 kgs with 758 kgs for outside bend in same tape.</p>	927 kgs

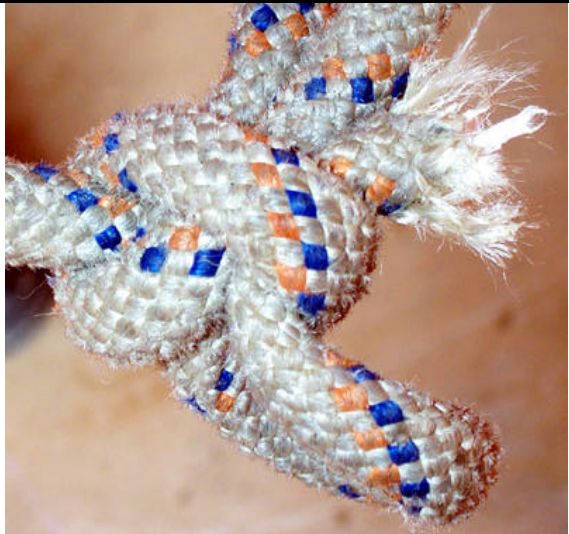
<b>Alpine Butterfly vs Alpine Clutch.</b>  Alpine Butterfly failed at 1065 kgs.	1065 kgs
