Load Testing

Alan Sheehan B.E.

The following load tests were completed in the Oberon State Emergency Service (SES) headquarters on the evening of July 29, 2004. The load cell is a StraightPoint NIP/5T 5 tonne load cell with remote read out unit. Calibration data confirms this load cell is accurate to +/- 2kgs over full scale. Force was applied using a 2.5 tonne Tirfor hand winch with a 2:1 MA pulley.

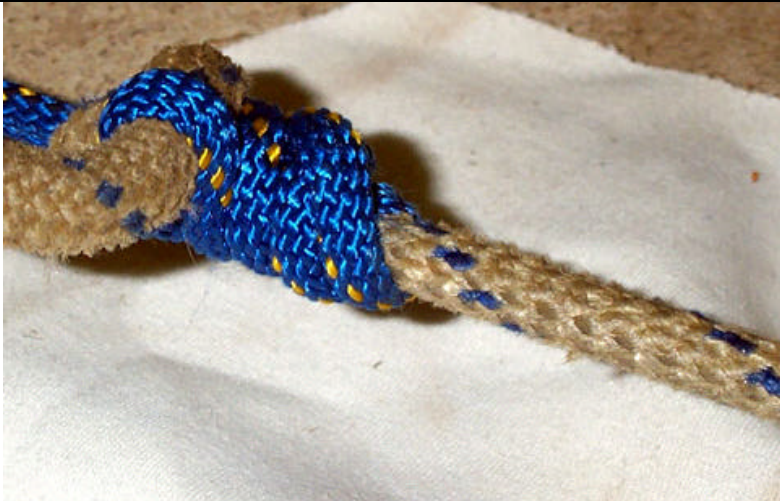
Prusik loop slipped at 921 kgs. Same prusik loop as above.
6mm 4 wrap Klemheist knot	935

Loop failed in the knot at 935 kgs after slipping approximately 210mm and twisting the 11mm load line until the knot could not slip anymore. If you ever want to make a rope simulate a boa constrictor... this is how you do it!

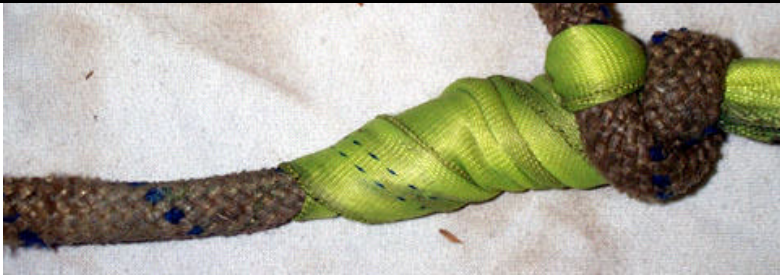
This knot was tested simultaneously with the abnormally loaded figure eight bend. Up until the figure eight failed, the Klemheist was behaving exactly the same was as the 6mm rope Klemheist in that it steadily twisted the 11mm load line as the knot slipped. The tape was 25mm mil-spec tube tape.

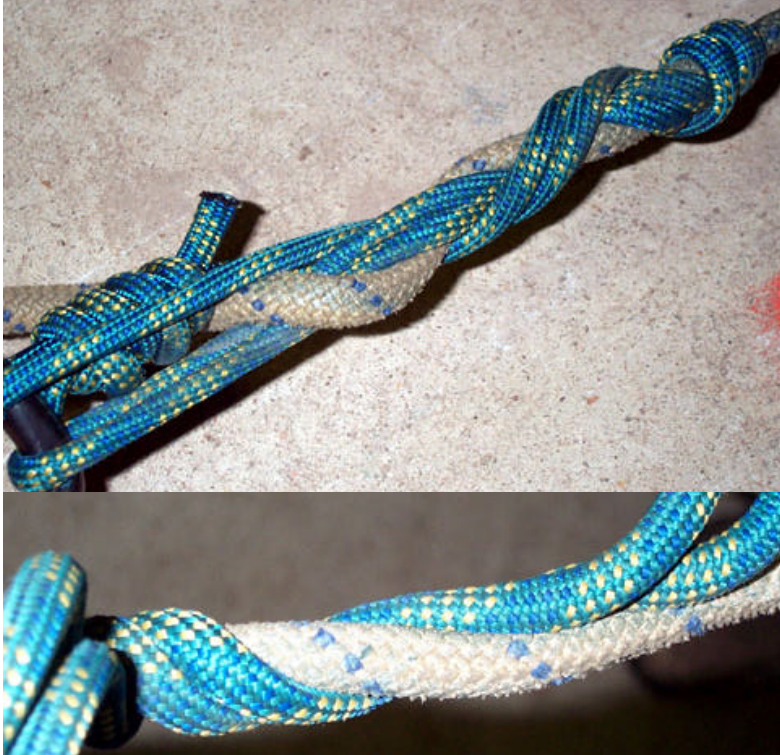
Slipped about 200mm at a maximum load of 773 kgs twice before welding to the rope. The prusik sling was fairly new 8mm static kernmantel cord. Note the weave patten of a French Prusik under load is similar to a rope dog, except that the overlapping part does not alternate as it does in a rope dog.
